A Look at Private Drinking Water Systems in the Upper-Middle Rideau Valley Watershed

June 2023

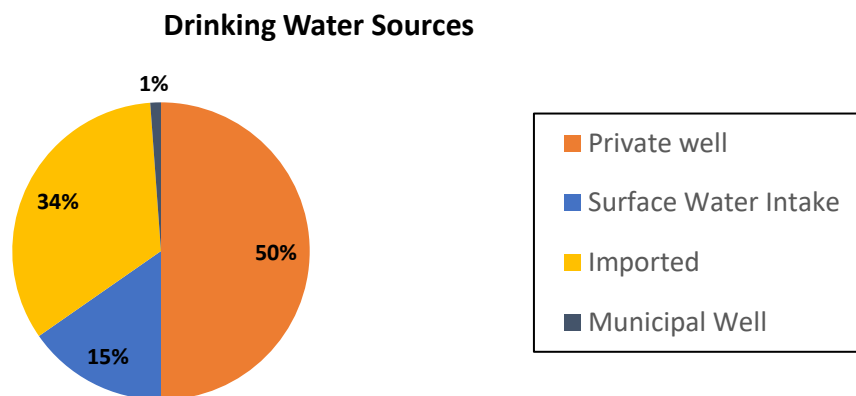
The drinking water source was determined from the survey question “What is your source of potable water?”. Results indicate 50% of lake residences source their drinking water from a private well, 15% from a surface water intake, and 34% are importing their drinking water. The remaining 1% have access to a municipal well.

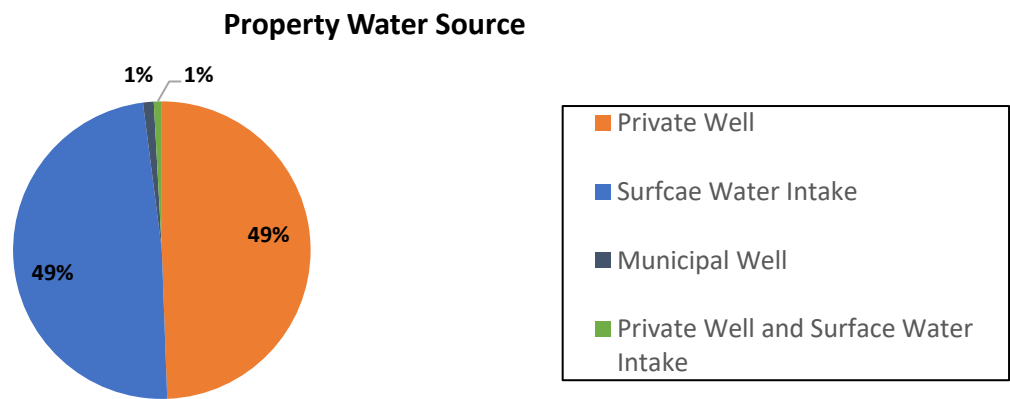
For this study it was inferred that individuals who indicated they import their drinking water, are not importing the water servicing their home but sourcing it from the lake, unless otherwise indicated. A thorough analysis of all survey responses was conducted to best determine the property water source. 18% of all survey results required the assumption that individuals importing their drinking water had a surface water intake, while the remaining 82% of responses indicated their property water source in their responses.

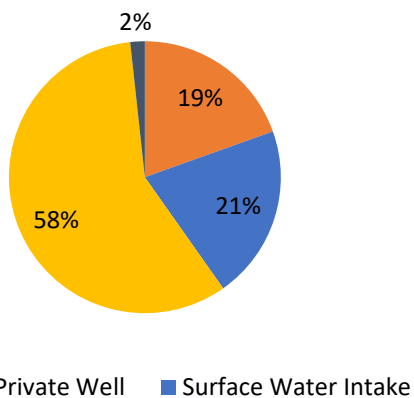
Seasonal Drinking Water Source

When comparing the drinking and property water sources of permanent homes to that of seasonal cottages, there was a notable difference. For permanent homes drinking water sources, 82% indicated they get their drinking water from a private well, 10% from a surface water intake, and 8% are importing their drinking water. In comparison, 19% of seasonal cottages indicated they get their drinking water from a private well, 21% from a surface water intake, and 58% are importing their drinking water.
